Contract #: 04-0120F4Cty: SF/ALA Rte: 80 PM: 13.2/13.9File #: 69.28**WELDING INSPECTION REPORT****Resident Engineer:**Pursell, Gary**Address:** 333 Burma Road**City:** Oakland, CA 94607**Report No:** WIR-009304**Date Inspected:** 21-Sep-2009**Project Name:** SAS Superstructure**OSM Arrival Time:** 645**Prime Contractor:** American Bridge/Fluor Enterprises, a JV**OSM Departure Time:** 1900**Contractor:** Zhenhua Port Machinery Company, Ltd (ZPMC), Changxing Island **Location:** Shanghai, China**CWI Name:** Chen fu you**CWI Present:** Yes No**Inspected CWI report:** Yes No N/A**Rod Oven in Use:** Yes No N/A**Electrode to specification:** Yes No N/A**Weld Procedures Followed:** Yes No N/A**Qualified Welders:** Yes No N/A**Verified Joint Fit-up:** Yes No N/A**Approved Drawings:** Yes No N/A**Approved WPS:** Yes No N/A**Delayed / Cancelled:** Yes No N/A**Bridge No:** 34-0006**Component:** OBG Components**Summary of Items Observed:**

WELDING INSPECTION REPORT

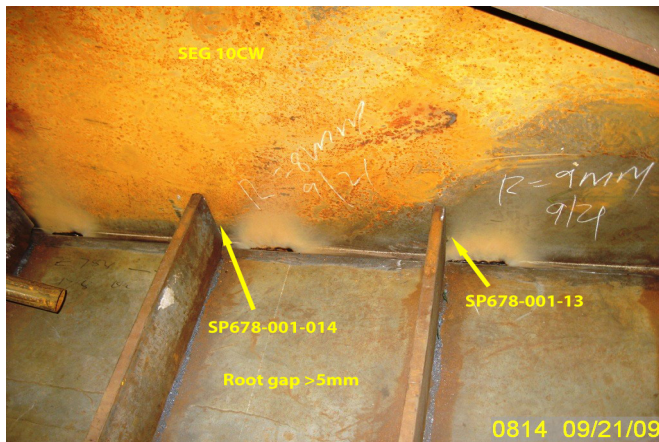
FCAW welding on ongoing repair welding due to root gap 11mm of weld joint SSD12-PP82-133 Of 9DW welder is identified as 066401.ZPMC QC is identified as Mr.Li ming yang. In this ZPMC Using backing bar, it is found that there is 3mm gap in between backing bar and weld joint. ZPMC started their welding. WPS-B-T-2233-B-U2a-FCM-F and WR7340. It is informed to

ZPMC QC Mr.Li ming yang and ABF QA Mr.Liu jin ping.
